**106-44-10090 Route Correction**

*Stream:* 106-44-10090

*Date Surveyed:* June 2013

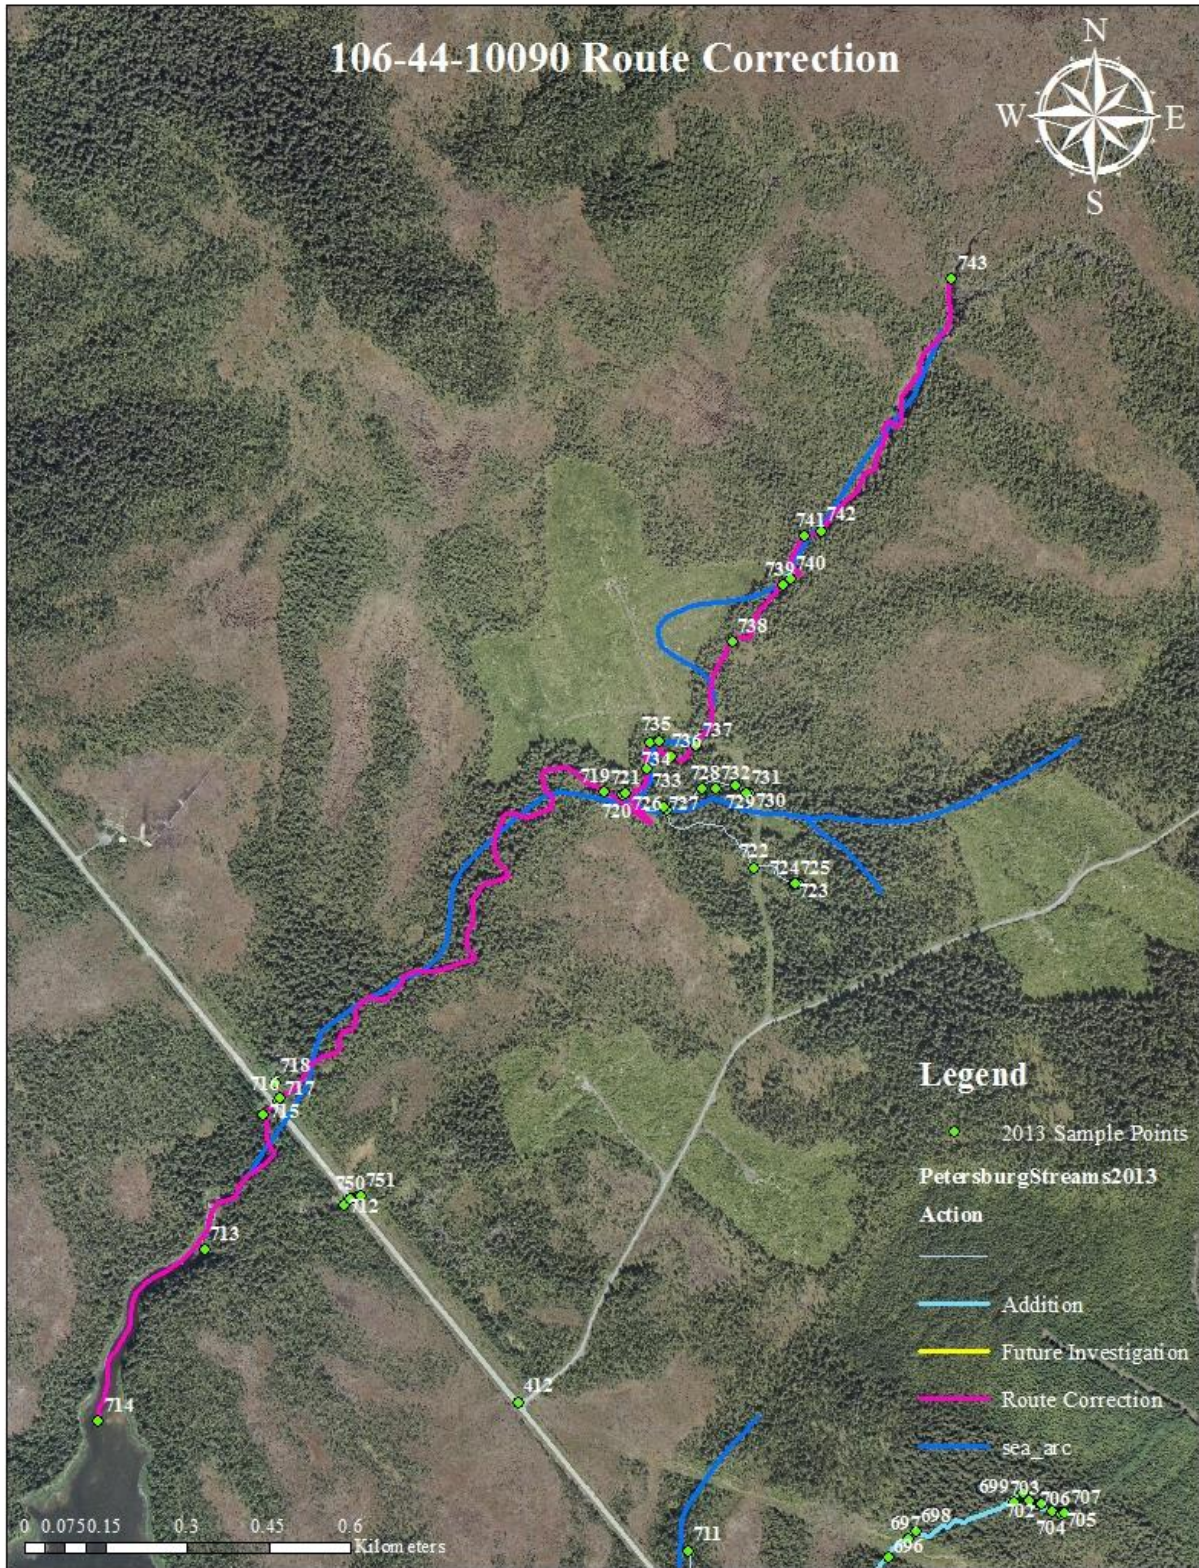
Figure 1. 106-44-10090 Route Correction map.

*Findings:* This stream's route differs from that illustrated in the AWC.

*Recommendations:* Update this stream's course to reflect its sinuosity in the AWC.
